# Koljoe Fjord observatory YSI EXO2 and AADI Seaguard October 2012 — April 2013

Mikhail Kononets, Dariia Atamanchuk, Anders Tengberg, Per Hall

May 7, 2013

The purpose of this document is to give a summary on YSI EXO2 and AADI Seaguard (sensor functioning and data quality) while the instruments were deployed as a part of Koljoe Fjord observatory from October 26, 2012 till April 24, 2013 (180 days).

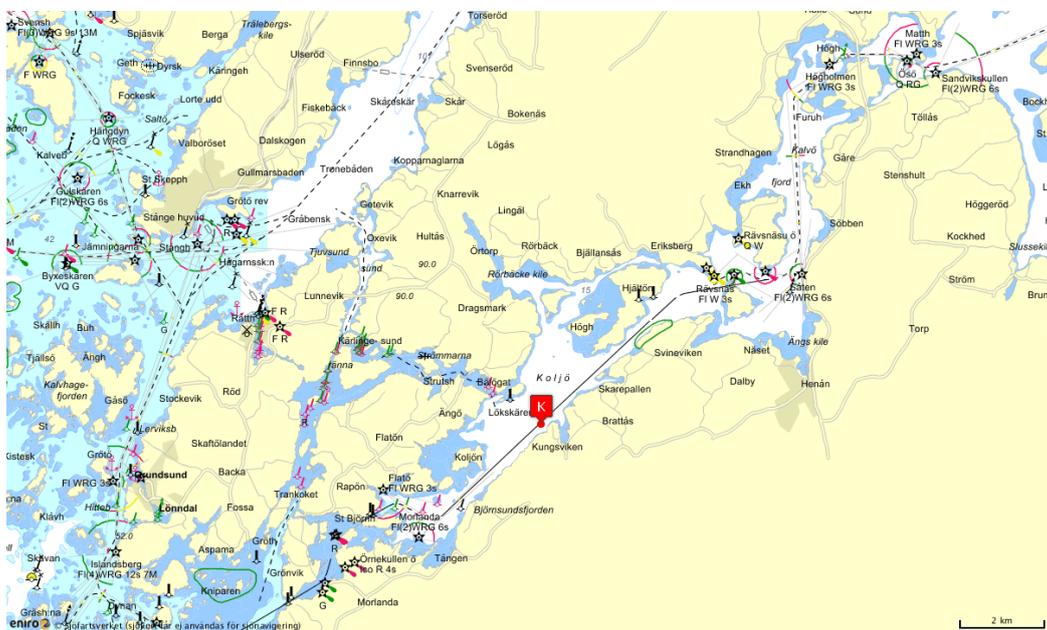
Figure 2: Koljoe Fjord observatory. As Koljoe Fjord is a part of monthly sampling program run by SMHI (Swedish Meteorological and Hydrological Institute). SMHI takes samples every 1 month (or as ice permits in winter). SMHI sampling station is around 100-200 m away from the observatory position. Parameters measured by SMHI are salinity, temperature, oxygen, hydrogen sulfide, and nutrients. Data are available on the web from the SMHI SHARK database.

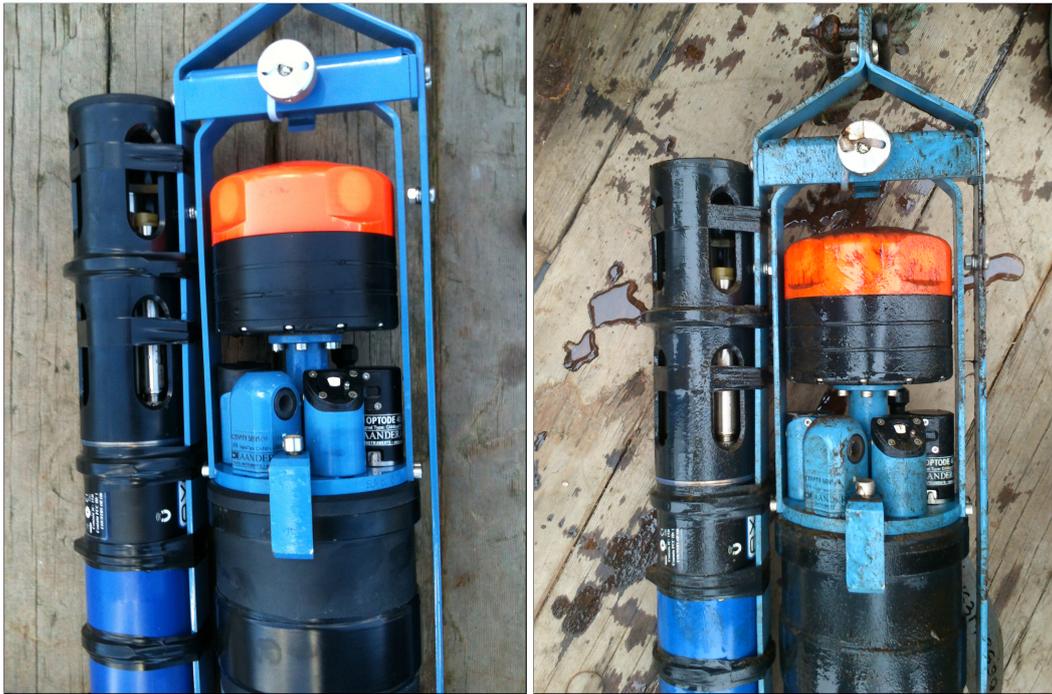
Seaguard and EXO2 before deployment (left) and on recovery (right). Water depth was about 5 m. EXO2 configuration/sensors:

- EXO2 Sonde, S/N 12E101339, FW 1.0.3
- pH/ORP, S/N 12H102556, FW 1.0.15
- Optical DO, S/N 12H101110, FW 1.0.8
- Total Algae BGA-PC, S/N 12H100744, FW 1.0.7
- fDOM, S/N 12H100041, FW 1.0.6
- Conductivity/Temp, S/N 12H101783, FW 1.0.5
- Wiper, S/N 12H101304, FW 1.0.3
- Depth Non-Vented 0-250m, S/N 12C101691, FW 1.0.4

Seaguard #67 configuration/sensors:

- CO<sub>2</sub> Optode 4797#21
- CO<sub>2</sub> Optode 4797#23
- DCS #43
- Conductivity #084
- Wave and Tide #239
- O<sub>2</sub> Optode 4835#154

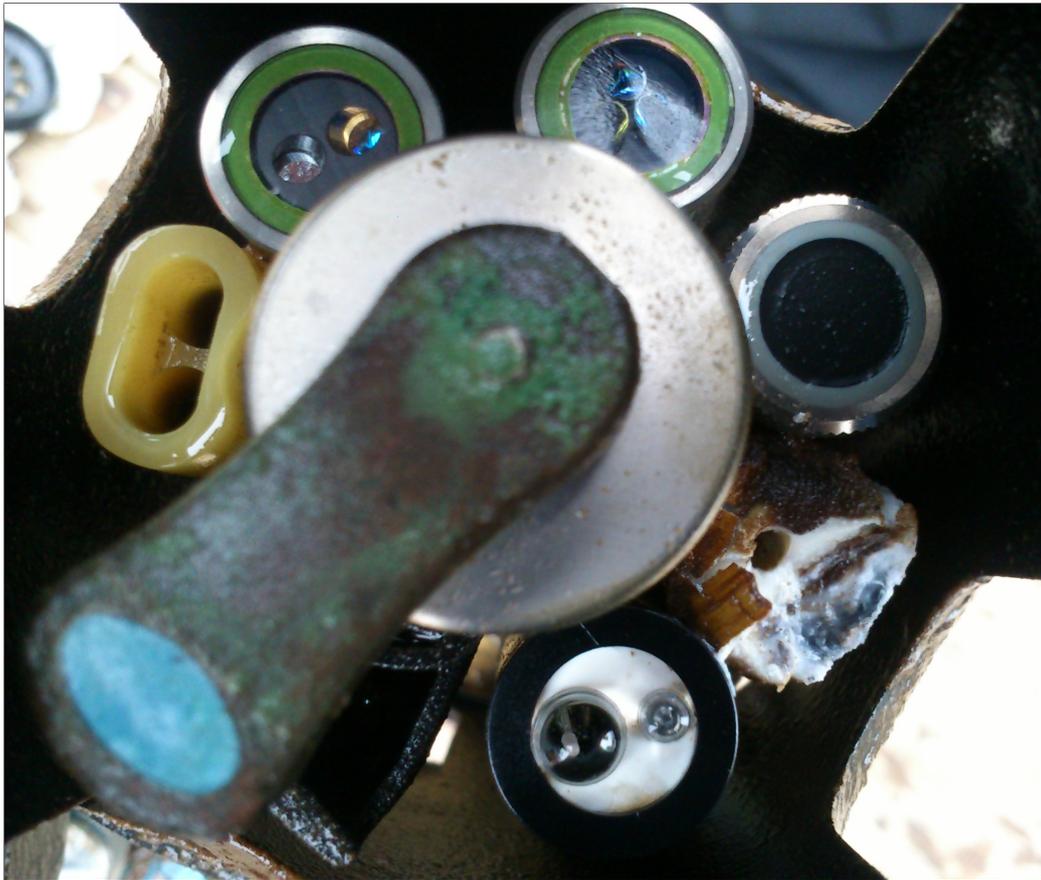
Figure 3: EXO2 sensor tips on recovery, before any washing or cleaning. Sensor sockets were populated with: C/T, fDOM, TA/BGA, ODO, sacrificial anode, and pH/ORP sensor. All sensors looked nice and clean after 6 months in sea water due to wiper brush cleaned working surfaces. Some consumption of sacrificial anode metal occurred.

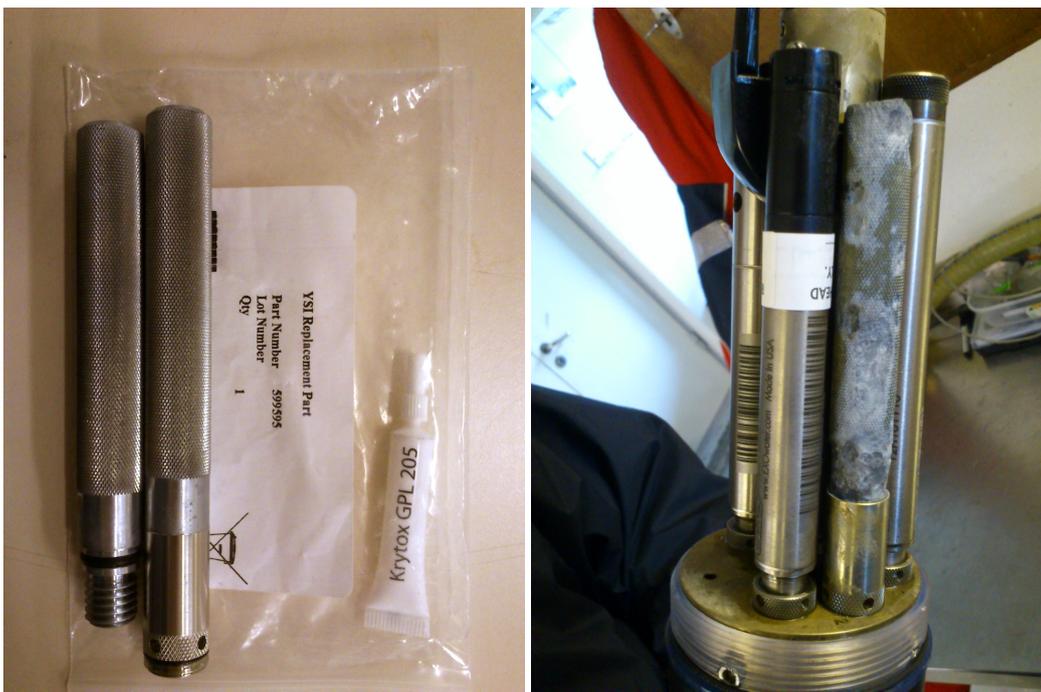
Figure 4: YSI EXO2 sonde, sacrificial anode before and after deployment (6 months under water).

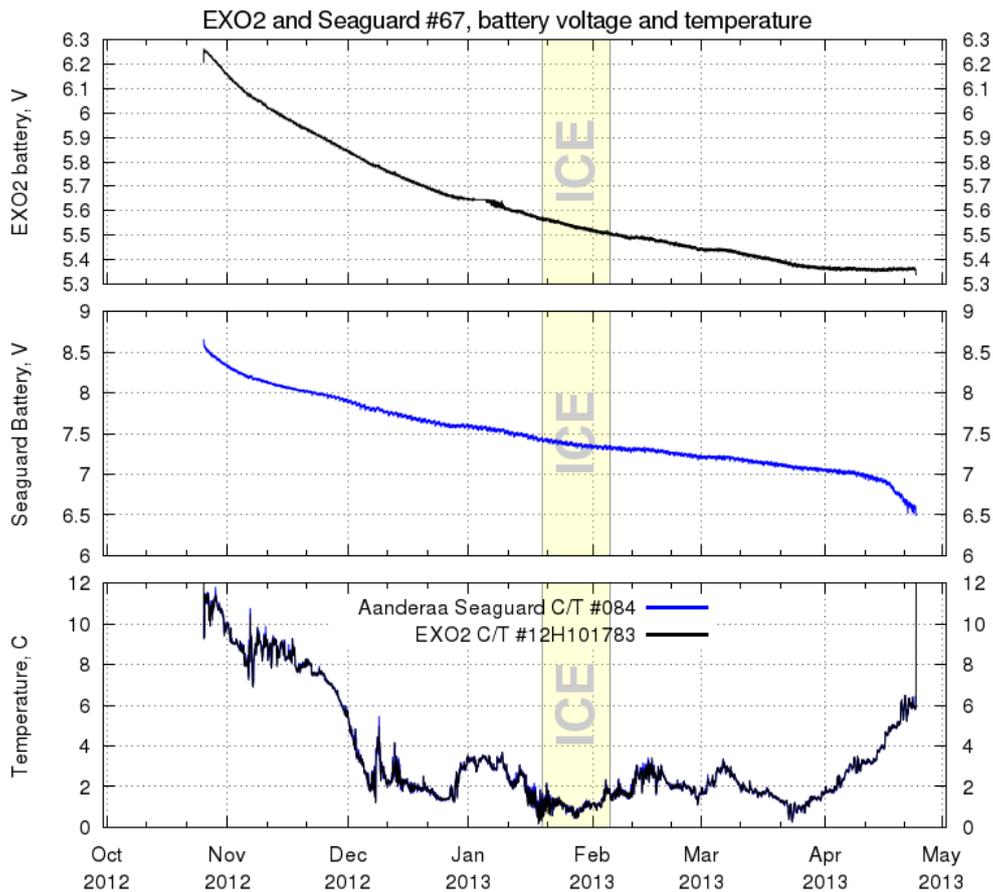
Figure 5: Seaguard and EXO2 Battery voltage. Seaguard was measuring every 30 min, EXO2 every hour. When water was quickly cooling down in Nov–Dec 2012, battery decline became faster. When water temperature increased, like in the end of December, in mid-February and 1st decade of March, battery decline became slower. EXO2 Voltage on recovery of 5.3 V corresponds to a single cell voltage of 1.33 V. Obviously EXO2 might work for much longer time, especially taking into account warmer temperature during the coming spring and summer time.

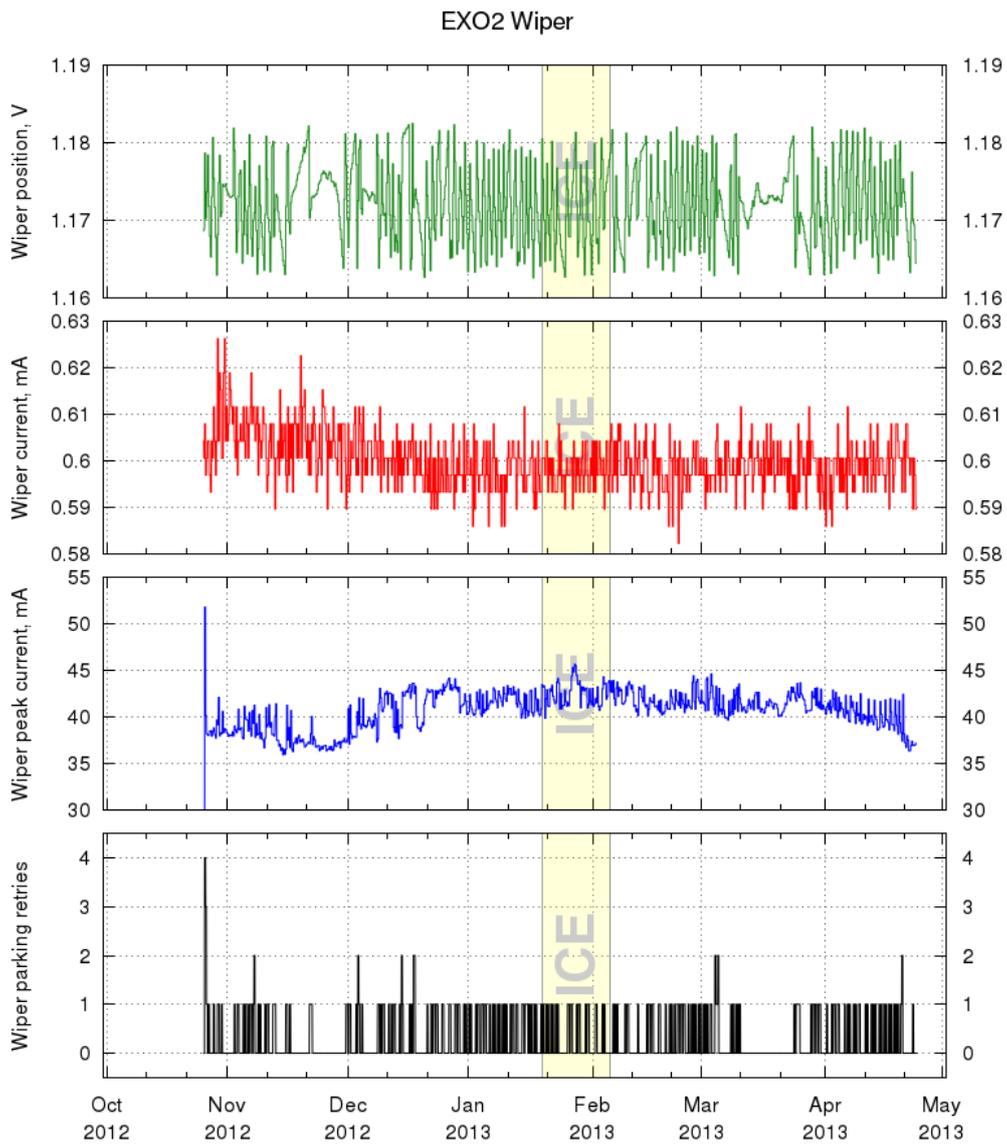
Figure 6: EXO2 Wiper.

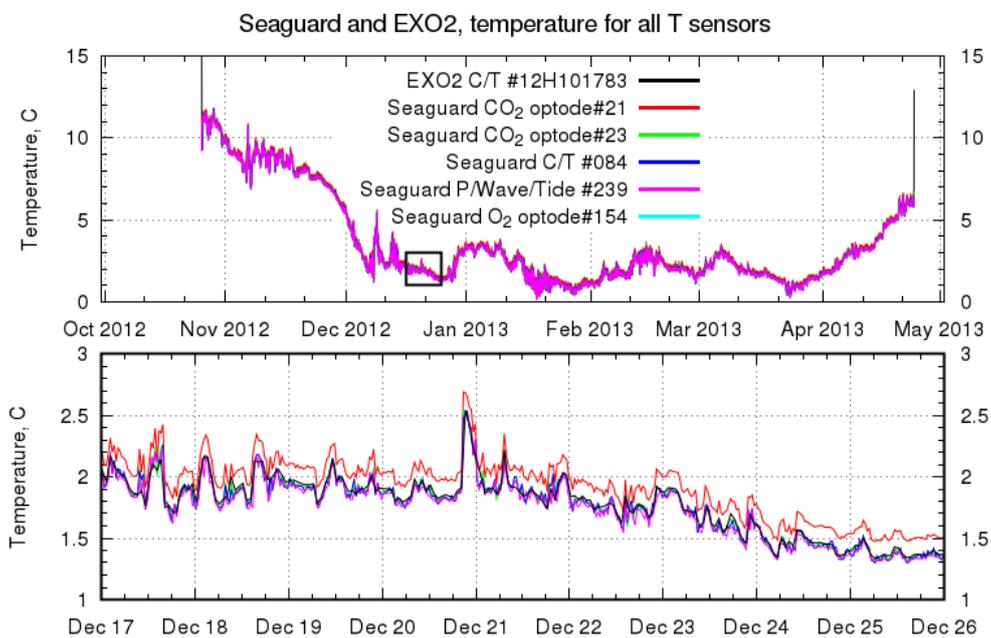
Figure 7: EXO2 and Seaguard, temperature from all sensors. pCO<sub>2</sub> optode #21 readings were always higher by 0.15 C. All other T sensor readings seem to agree very well.

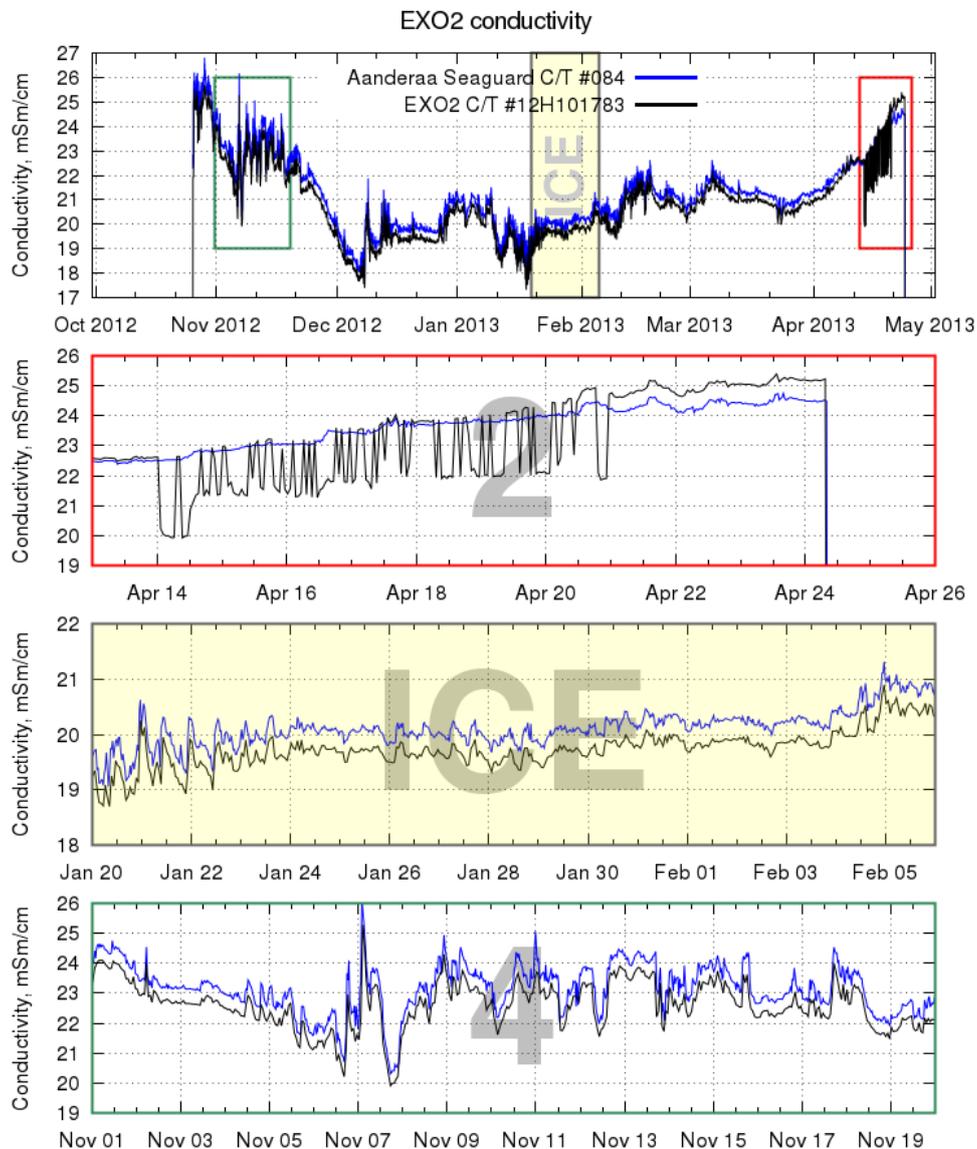
Figure 8: EXO2 Conductivity. Panel 2 show some strange oscillations shown by EXO2 conductivity, but not by Aanderaa conductivity sensor. The oscillations could have been due to some algae which could have entered the C cell and washed out by currents later. Usually EXO2 conductivity showed a negative offset of around 0.5 mSm/cm against Aanderaa conductivity except in April 2013, see panels ICE and 4 as examples. In April 2013 Aanderaa C sensor could have been affected by fouling, which decreased Aanderss conductivity readings. That's probably the reason for the offset between EXO2 and Aanderaa gradually changed and became positive.

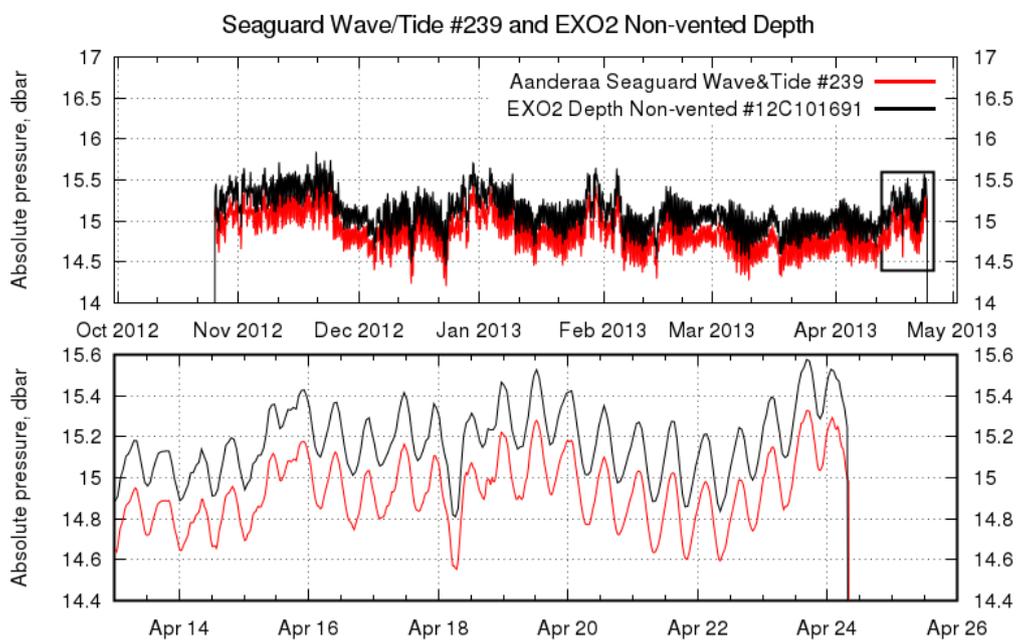
Figure 9: EXO2 Pressure. Periodical oscillations due to tidal movements of sea level (shown on lower panel). Permanent offset of approx 22 cm suggests difference between depth levels of pressure sensors on EXO2 and Aanderaa Seaguard.

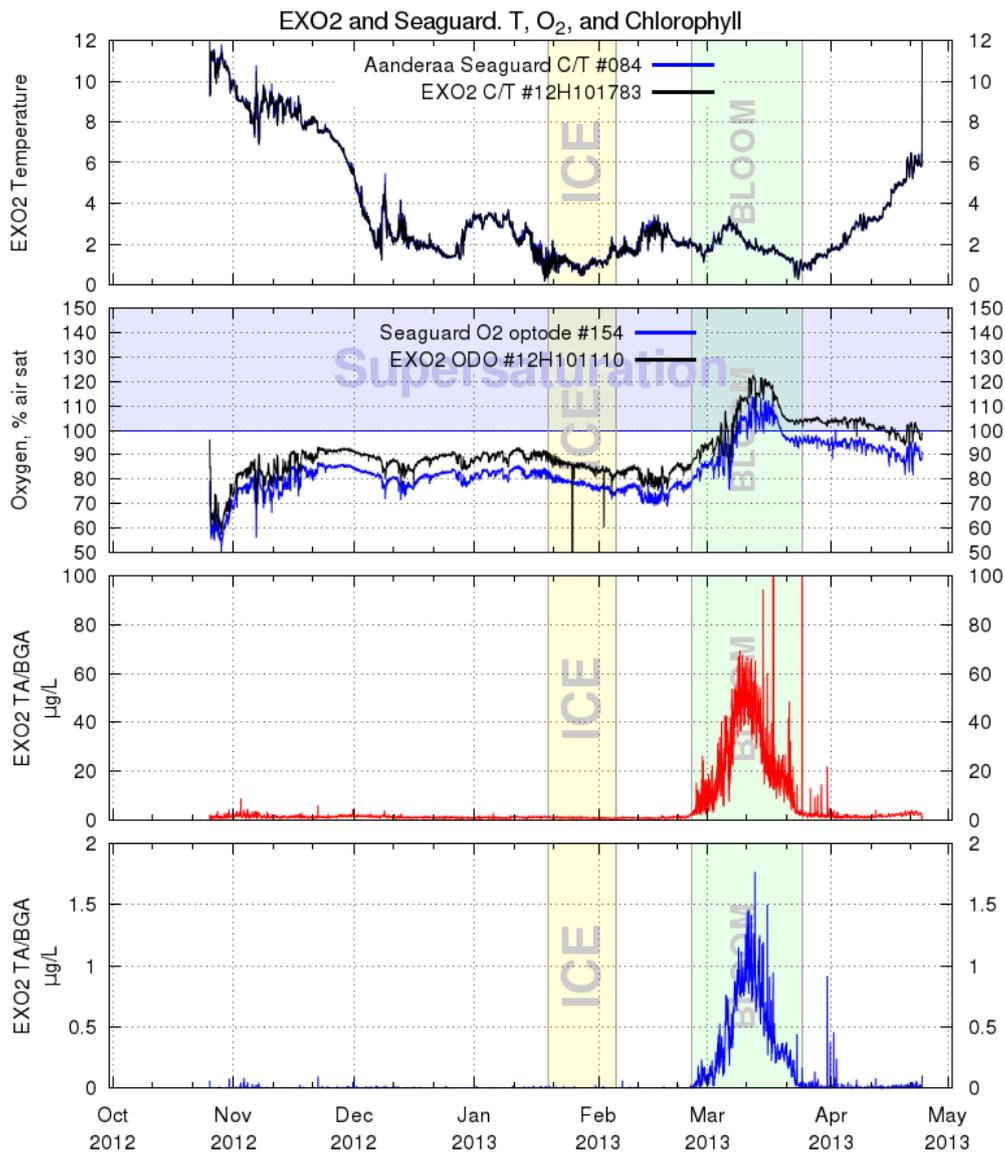
Figure 10: EXO2 oxygen and temperature. Two negative spikes shown by EXO2 ODO in Jan and Feb 2013 were probably due to sacrificial anode protection at very low currents when the fjord was covered with ice. The peak of O<sub>2</sub> supersaturation in March 2013 corresponds to the peak of chlorophyll confirming spring algal bloom in March 2013. Cyanobacterial chlorophyll (BGA) was a very small fraction of total chlorophyll (TA). After the end of bloom water temperature started to increase keeping O<sub>2</sub> levels close to full saturation, while absolute concentrations of oxygen decreased. EXO2 ODO saturation readings on deck on recovery after the bloom (with wet protective cap on) were always around 100%, while Aanderaa oxygen optode readings were approximately 5% lower.

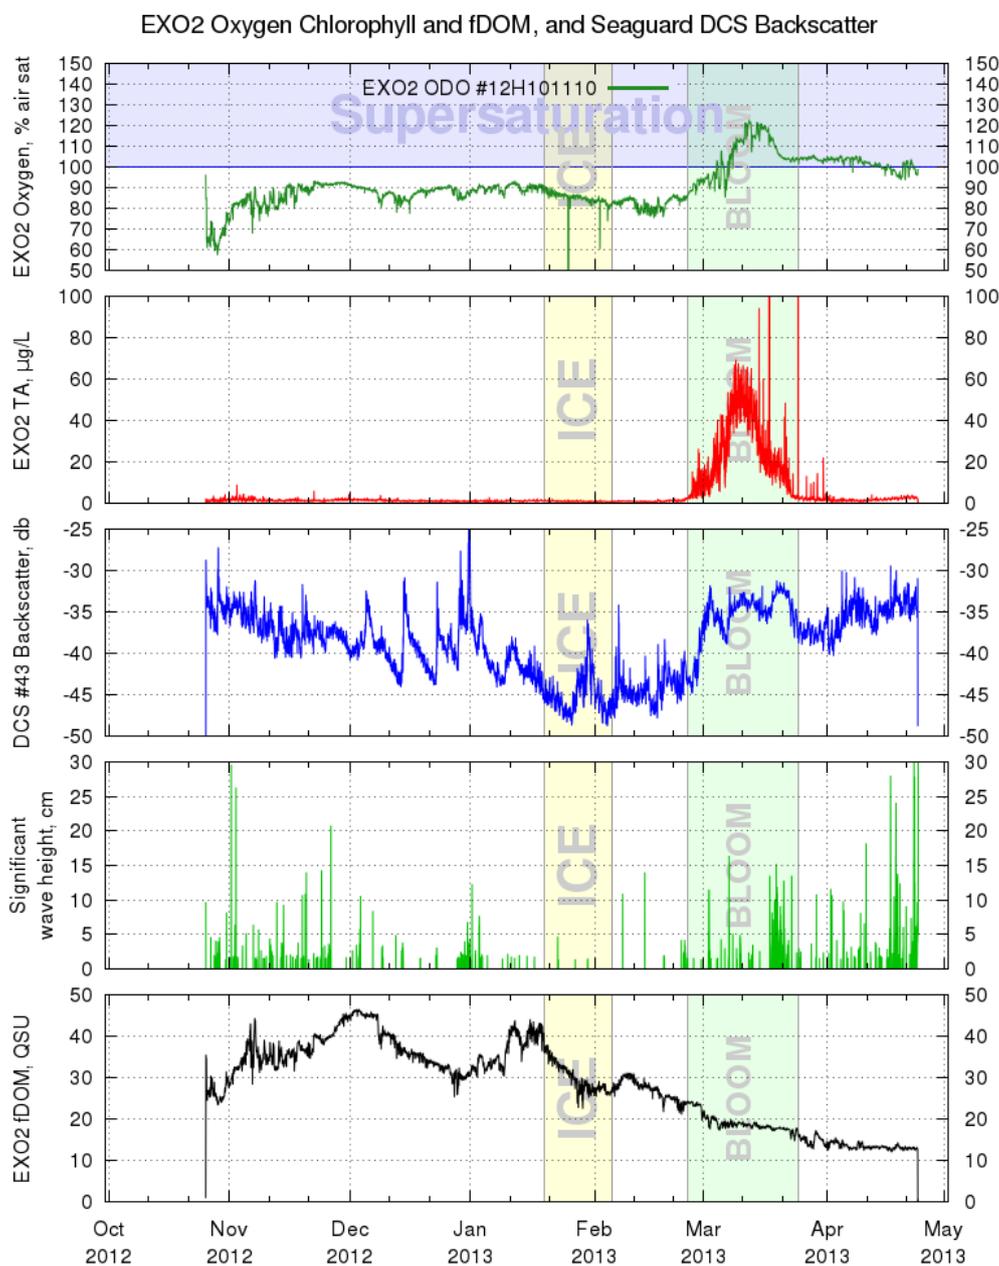
Figure 11: EXO2 and Seaguard. Oxygen, chlorophyll, fDOM and backscatter intensity from acoustic pulses emitted by Seaguard DCS (current sensor). Acoustic signal got improved due to organic matter produced by the bloom (oxygen and chlorophyll peak). Oxygen decrease from above 120% supersaturation down to 100% at the end of bloom (decreasing TA values) was most likely due to wind-induced waves and currents. There seems to be no relation to fDOM signal.

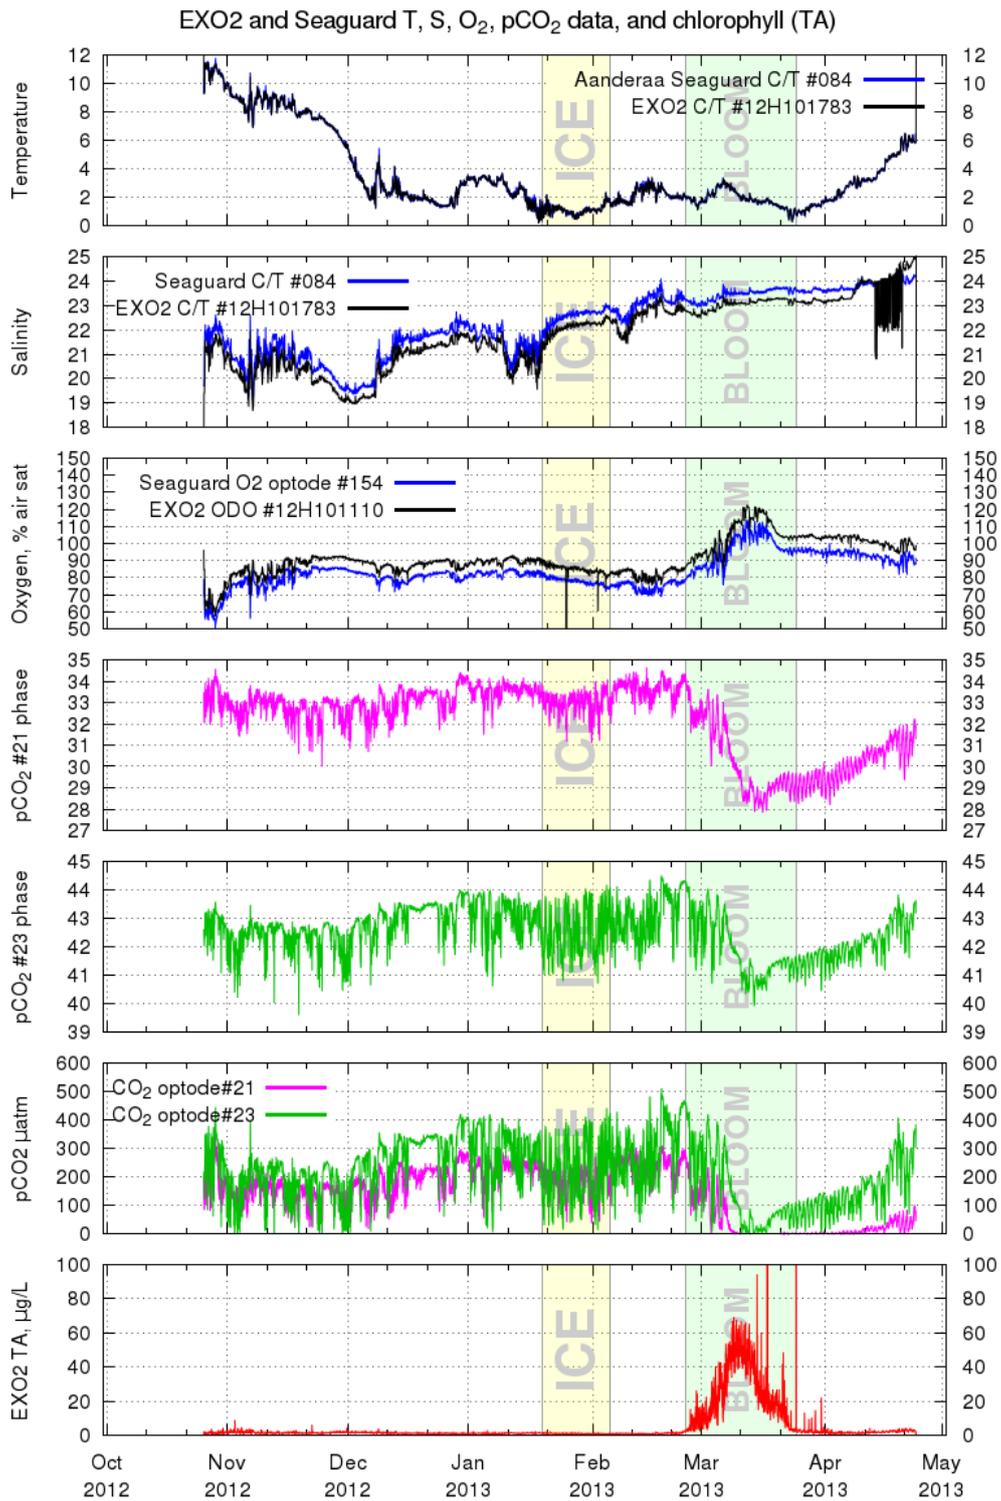
Figure 12: Seaguard and EXO2. T, S, oxygen, CO<sub>2</sub>, TA and BGA Chlorophyll data. O<sub>2</sub> supersaturation peak during the bloom corresponds to the minimum on CO<sub>2</sub> data. Raw CO<sub>2</sub> data look good, but calibration for CO<sub>2</sub> optode #21 is most likely not valid.

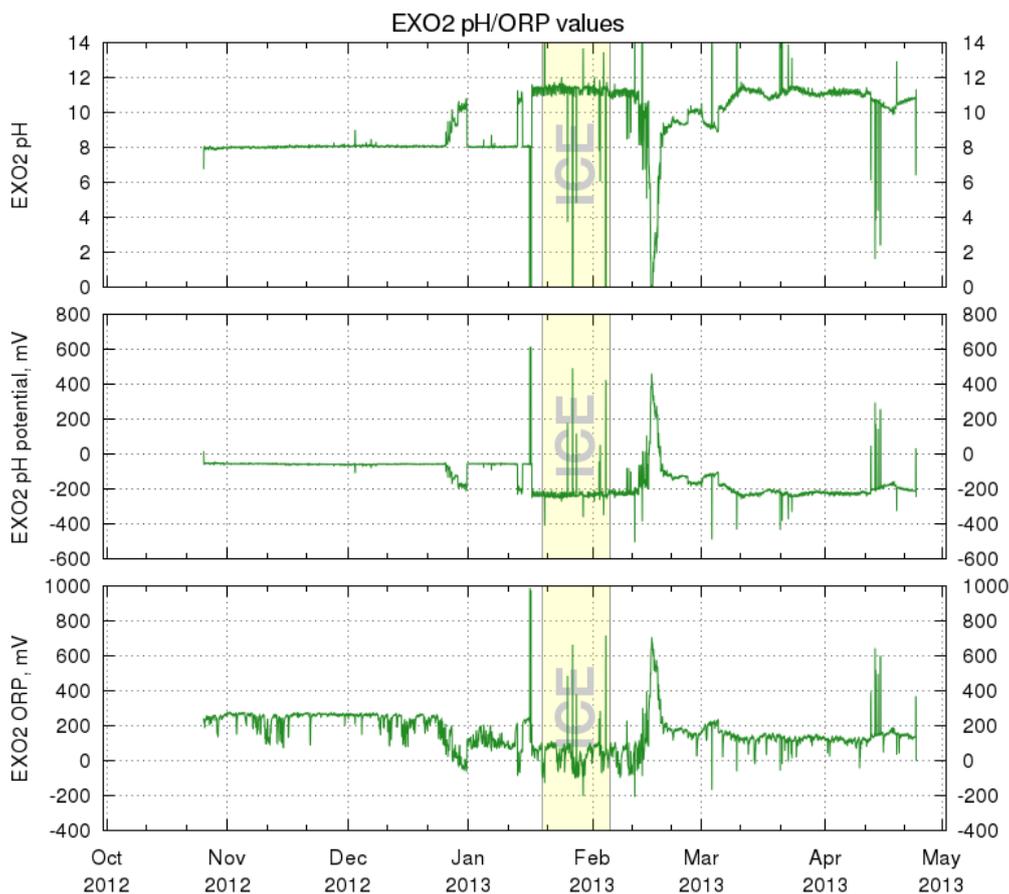
Figure 13: EXO2 pH/ORP. Something went really wrong first in the end of December, then in mid-January. After recovery when testing pH readings in lab with small protective cap on, filled with buffer solution, pH was good and stable: for pH 4 readings were 4.0, for pH 7 readings were 7.2, for pH 9.2 readings were 9.4. pH/ORP values immediately went wrong (pH about 2 pH up and unstable) as soon as electrical contact between the pH sensor and the metal of sensor body was re-established (via the solution inside the calibration cap, or just by touching the edge of protective cap and metal of sensor body with wet fingers of the same hand).

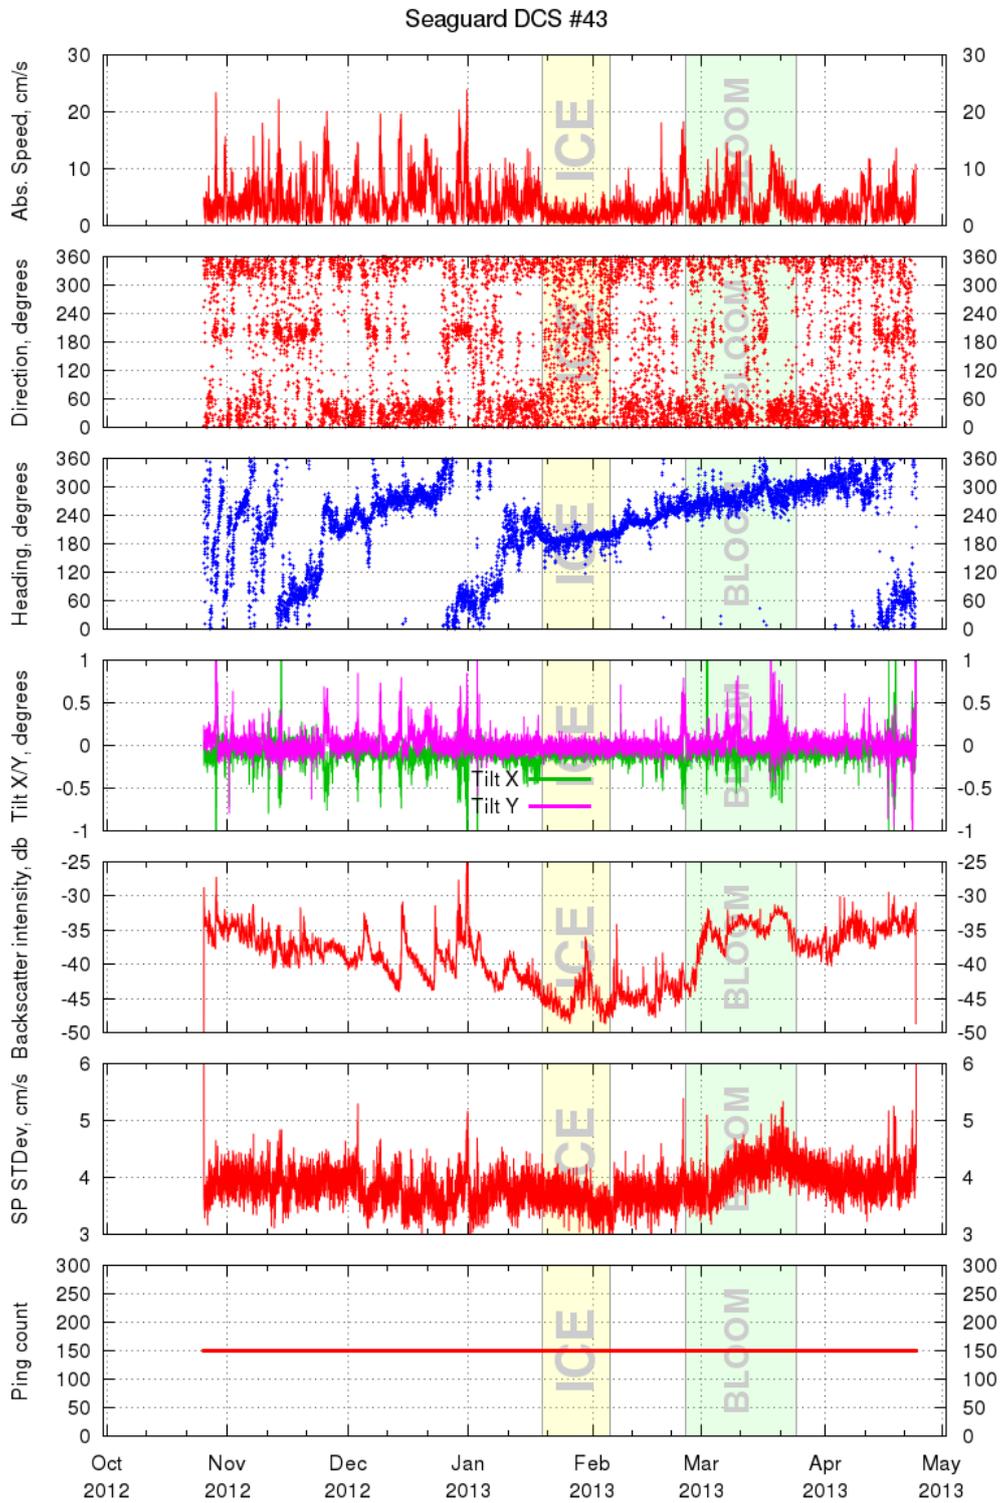
Figure 14: Seaguard DCS #43 data. Weak currents, chaotic direction and quite stable heading under ice.

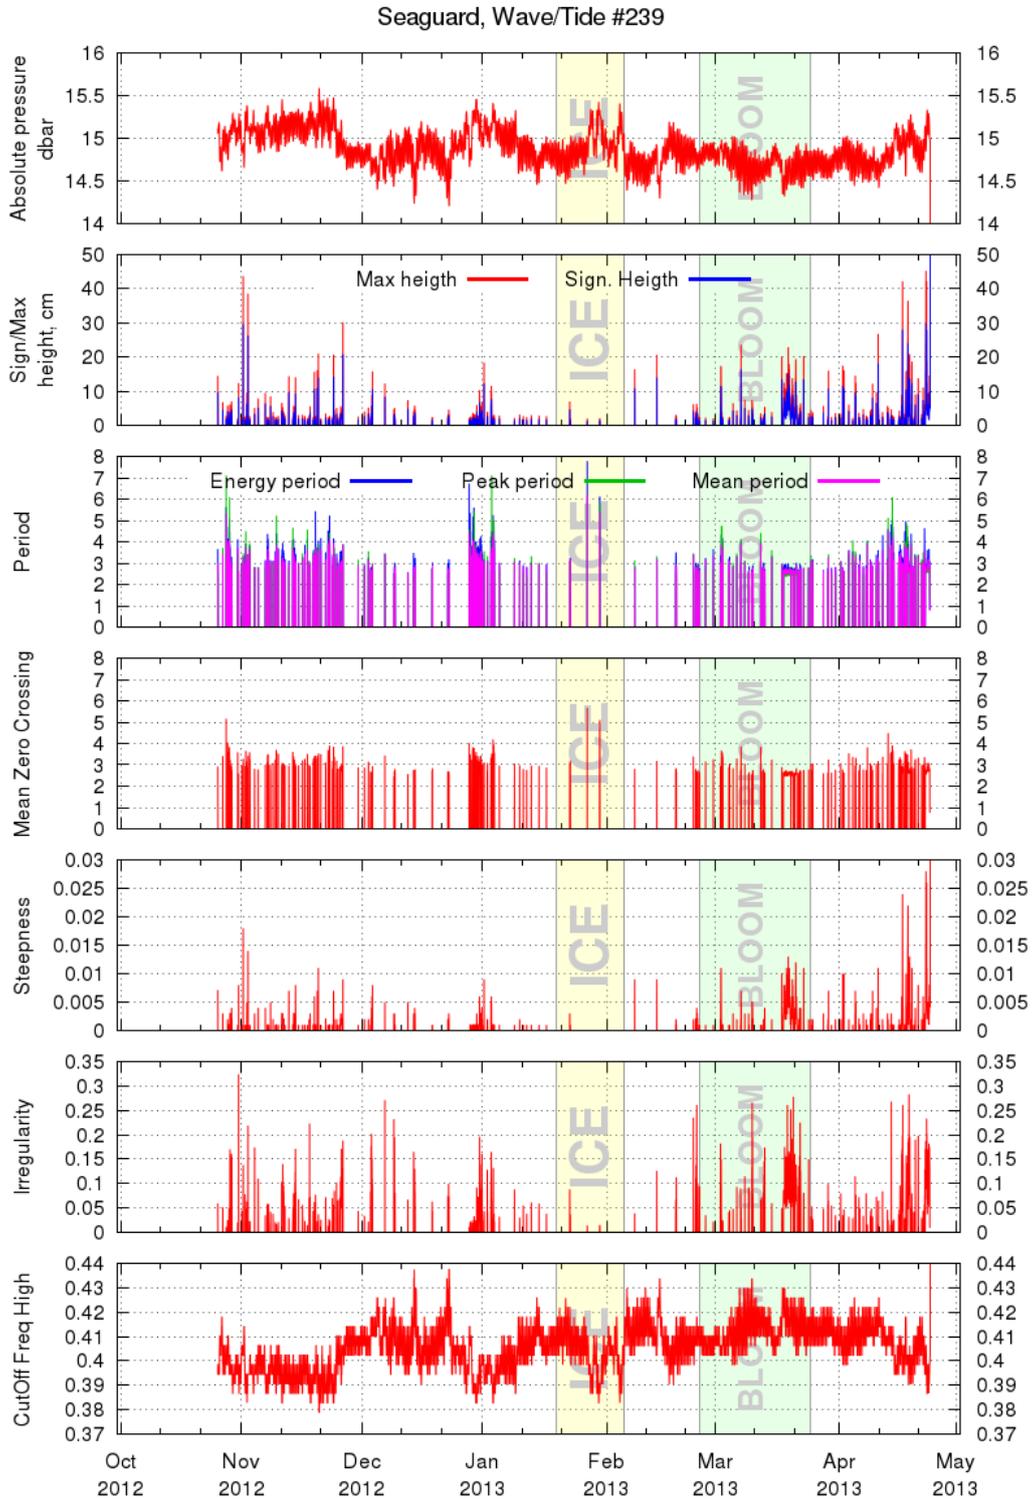
Figure 15: Seaguard Wave/Tide sensor #239 data. A period with strong waves in mid-March 2013 at the end of the bloom.

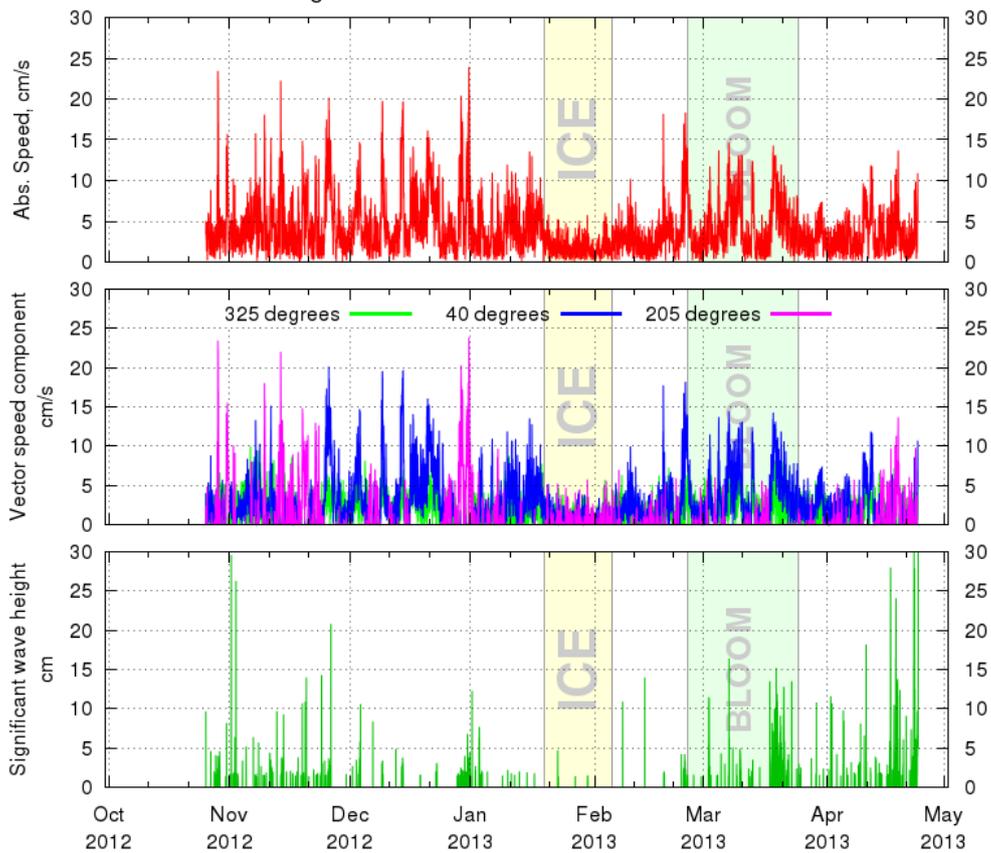
Seaguard DCS #43 and Wave/Tide #239 data

Figure 16: Seaguard DCS #43 and Wave/Tide #239, current and wave data. Very weak currents under ice. A period with strong waves in mid-March 2013 at the end of the bloom.

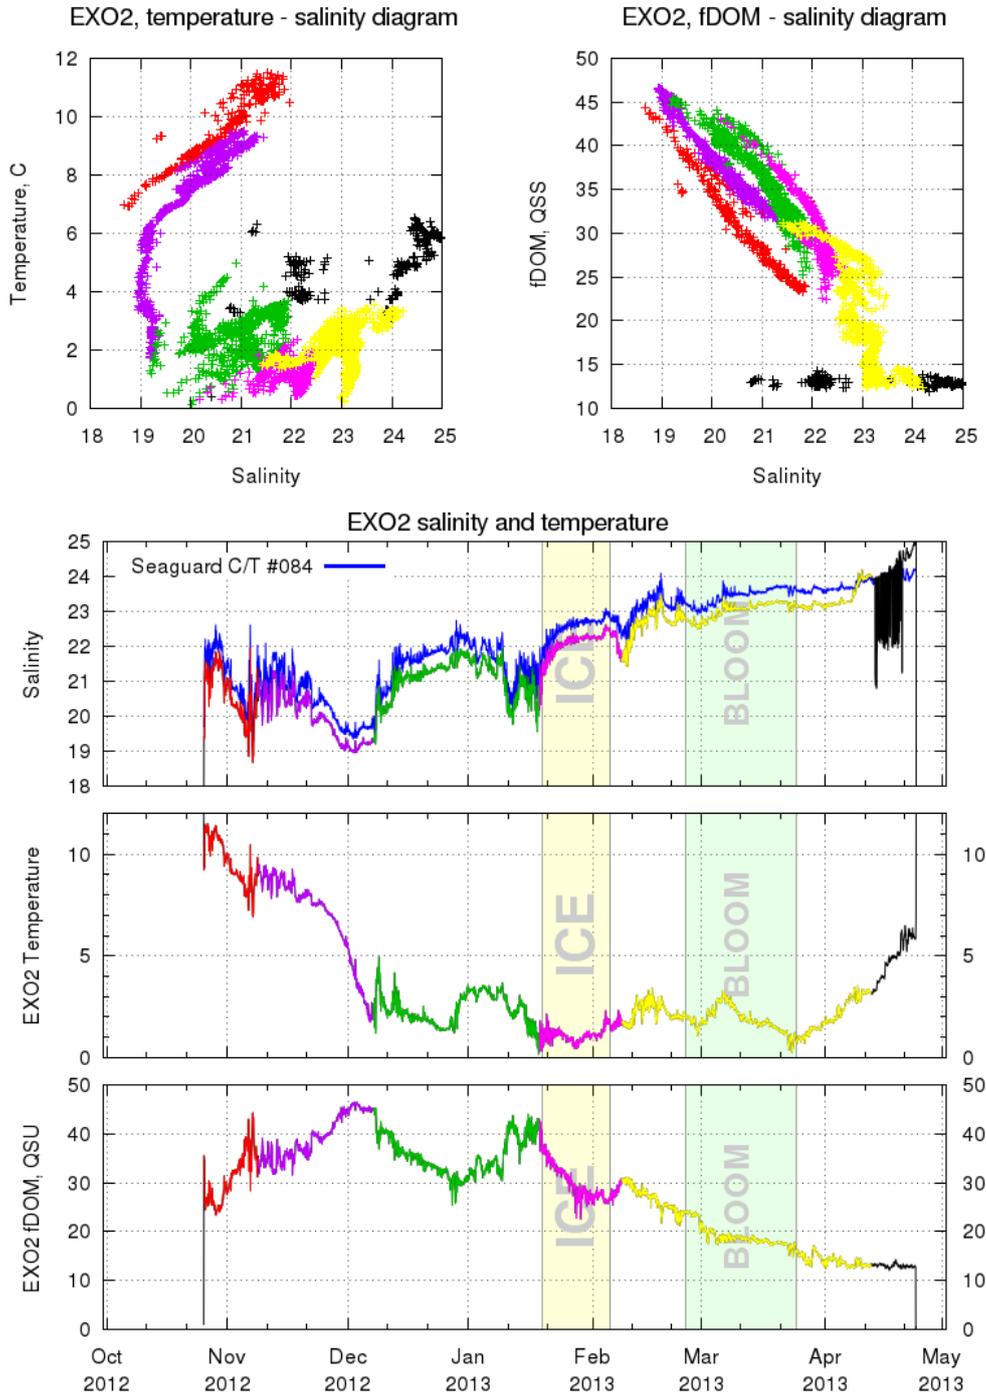
Figure 17: EXO2 temperature, salinity, and fDOM as indicators of water exchange/mixing.
